CITY OF HUTCHINSON

DOWNTOWN GAP SURVEY

CHAPTER 1 · INTRODUCTION

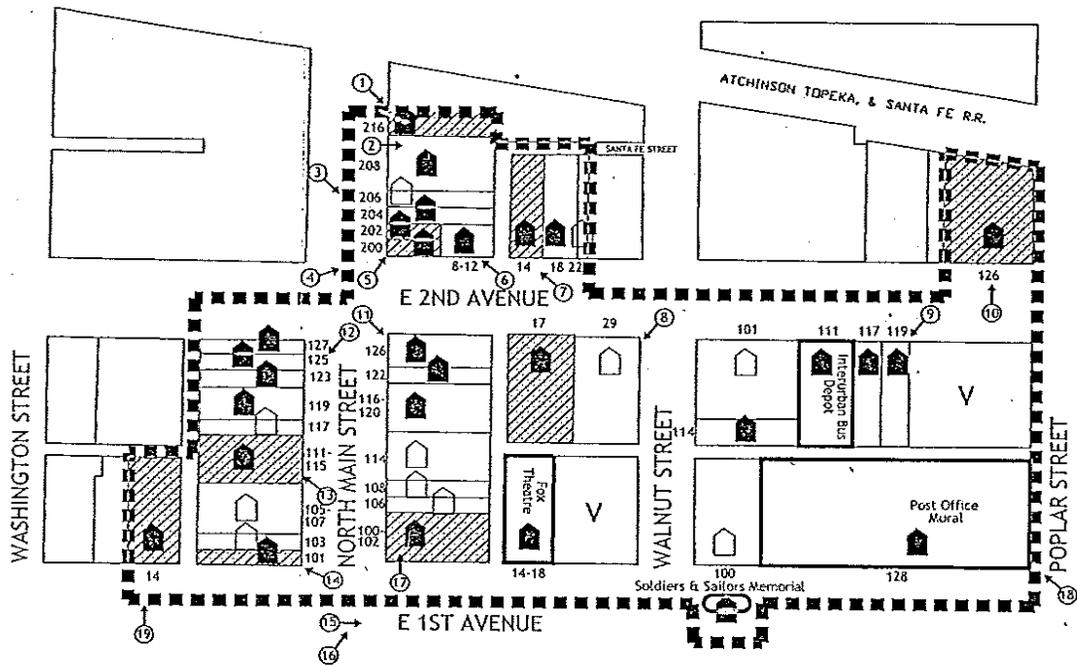
Figure 1 (above): Downtown Core North Historic District. Figure 2 (below): Infilled flags indicate contributing properties. Hollow flags indicate non-contributing properties. Hatch marks indicate “key contributors.”

Although many downtown properties, including some within the Downtown Gap Area, were surveyed in the early 1990s, historic preservation planning for downtown Hutchinson began in earnest a decade later. In early 2002, the City of Hutchinson received a Historic Preservation Fund Grant from the Kansas Historical Society to nominate “selected” downtown properties to the National Register of Historic Places. As part of the project, consultant Deon Wolfenbarger developed a Multiple Property Nomination entitled “Commercial and Industrial Resources of Hutchinson” and National Register nominations for two downtown historic districts, both listed on the National Register of Historic Places in 2004. The Downtown North Historic District (see Figure 1) encompassed properties along Main Street and east to Poplar, bounded on the south by First Street and roughly on the north by the Santa Fe Railroad tracks. The Downtown Core South Historic District (see Figure 2) included mostly properties south of Avenue A.

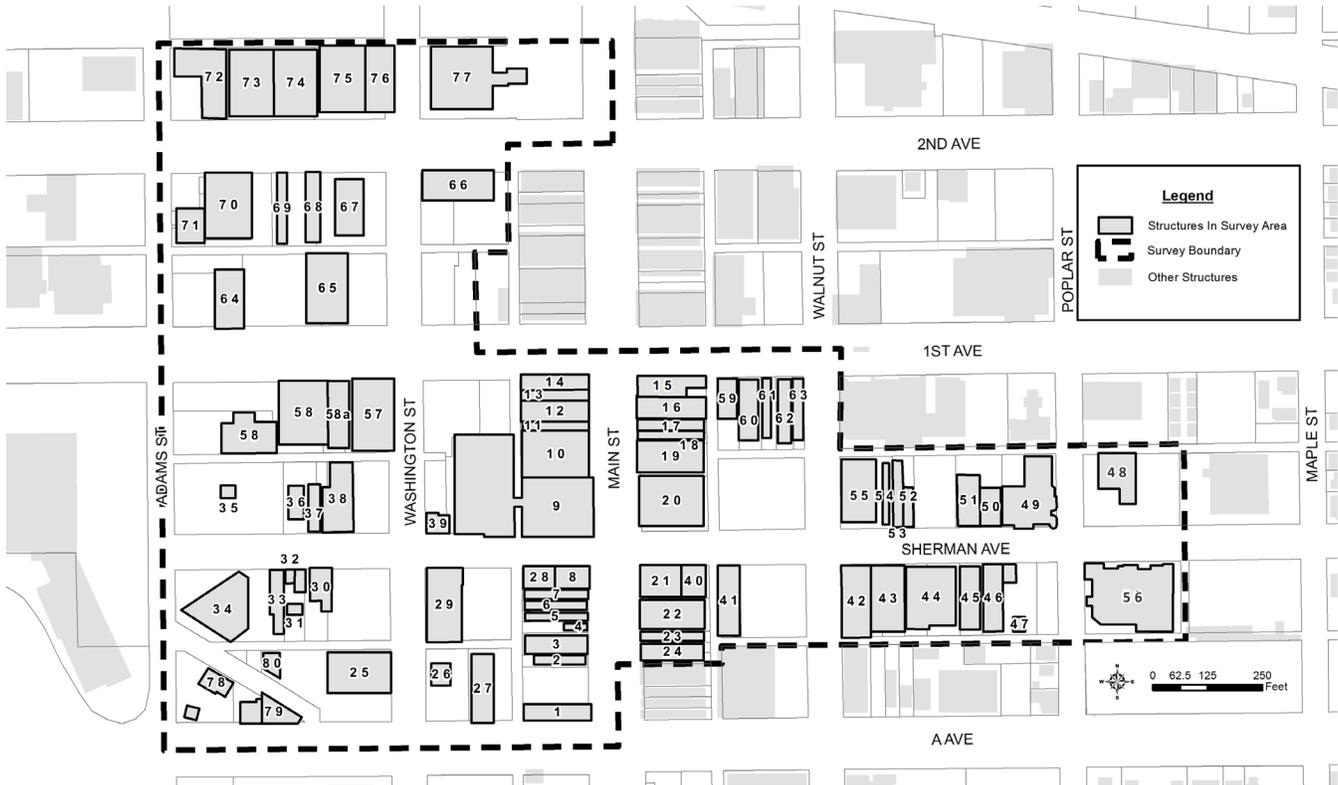
Figure 3: Downtown Gap Area Survey, Survey Boundaries.

The survey area (see Figure 3) includes properties facing West Second west of the alley between Washington and Main; properties on the north side of West First, between Adams and Washington; properties on the south side of First between Adams and Walnut; properties facing Sherman between Adams and the alley between Poplar and Maple; properties on the north side of Avenue A between Adams and Main; properties on the west side of Main Street from First to Avenue A; and, finally, properties on the east side of Main between First Street and south to include 18 S. Main (Survey Sequence #24). Each property within the survey area was given an inventory number. The west side of Main Street was surveyed first, south to north (Properties #1-14). The east side of Main Street was surveyed second, north to south (Properties #15-24). Properties on east/west side streets – Avenue A, Sherman, First and Second - were surveyed third (Properties #25-77).

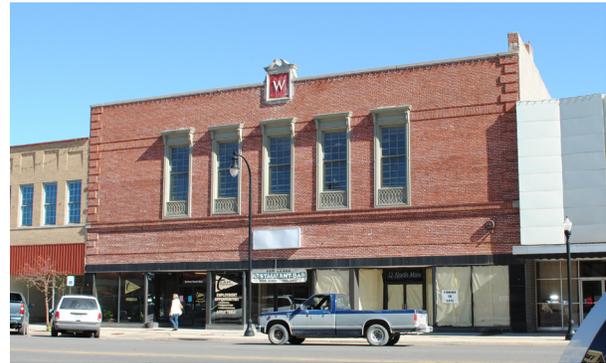
One (1) building, the Montgomery Ward Building at 14 N. Main (Sequence #19), is classified as Colonial Revival. Interest in the Colonial style swelled after Philadelphia's 1876 Centennial Exposition and the associated restoration of Independence Hall. By the 1920s, revival-style homes – Colonial Revival, Dutch Colonial Revival and Tudor Revival – filled thousands of American subdivisions. Colonial Revival was less popular for commercial buildings. The few exceptions to the rule are in suburban shopping centers dating from the 1930s to circa 1960 and a handful of downtown commercial applications, including Montgomery Ward buildings nationwide. Formerly a catalog company, Montgomery Ward opened first its retail store in 1926, and expanded its retail presence rapidly throughout the 1930s with the construction of distinctive Colonial Revival buildings in downtowns nationwide.

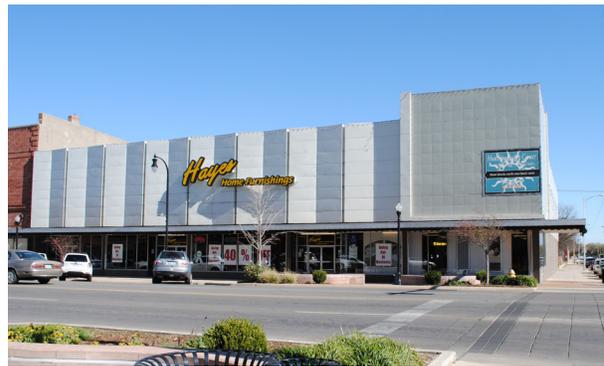
Modern/Modern Movement

There are seventeen (17) Modern buildings in the survey area. The “Modern” classification generally encompasses the mid-century buildings marked by simple form and lack of architectural adornment. They tend to be more angular than Streamline/Art Moderne buildings.

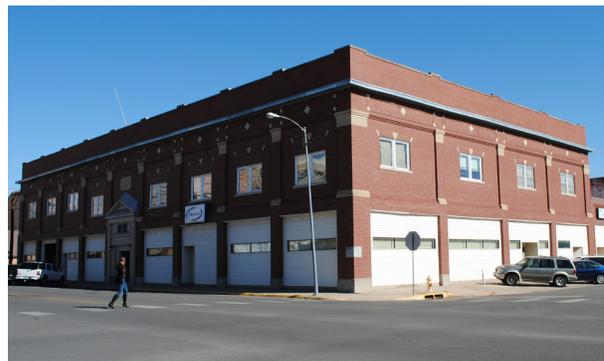
One (1) building, the Armory/Salt City Business College, is classified as Neoclassical. As its name implies, Neoclassical Architecture draws on the influences of Classical architecture from ancient Greece and Rome. Character-defining features of Neoclassical include symmetry, columns, pediments, entablatures, dressed stone, dentiling and shallow hipped or flat roofs. The style was

often employed in the 1910s and 1920s, after the City Beautiful Movement popularized free-standing buildings for public and institutional uses. Neoclassical is generally differentiated from Classical Revival by the occurrence of columns, pilasters or piers that span multiple stories.

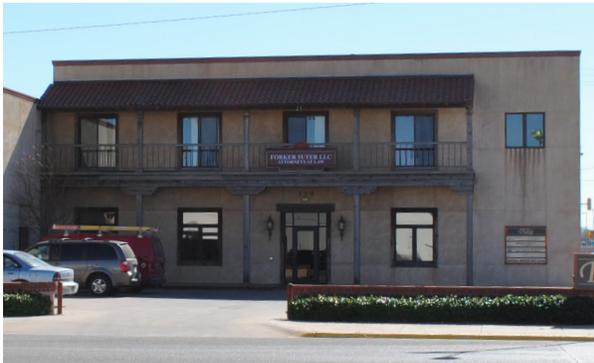
Pueblo Revival style architecture draws its inspiration from the traditional adobe construction of the pueblos in the Southwest United States. Character-defining features include the use of stucco and heavy timbers to replicate the look of adobe construction. Two (2) buildings in the survey area are classified as Pueblo Revival. The appearance of both buildings dates to a 1985 redevelopment called “The Plaza.”

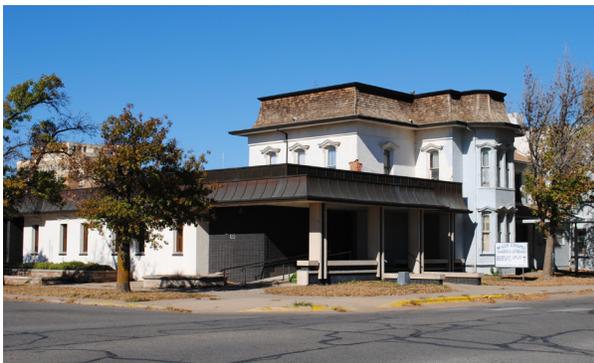
The Second Empire Style was employed principally in residential buildings of the mid to late nineteenth century. The style shares many of the character-defining features with the Italianate Style – except they are identified by their Mansard roofs, a French innovation from the reign of

Louis Napoleon which created an additional non-taxed level of occupiable space. There is one (1) example, the Wilcox House/Funeral Home, in the survey area.

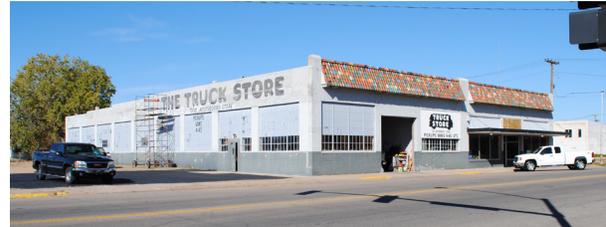
Spanish Eclectic architecture takes its cues from old-world architecture. The style, popular nationwide from 1915-1940, was adopted for both residential and commercial architecture. Character-defining features include low-pitched roofs with clay tiles or pan (metal made to look like clay tile) tiles, arched openings, multi-pane windows, and stucco or blond brick exteriors with polychromatic terra cotta. Four (4) buildings in the survey area are identified as Spanish Eclectic, all of them auto-related buildings from the 1920s.

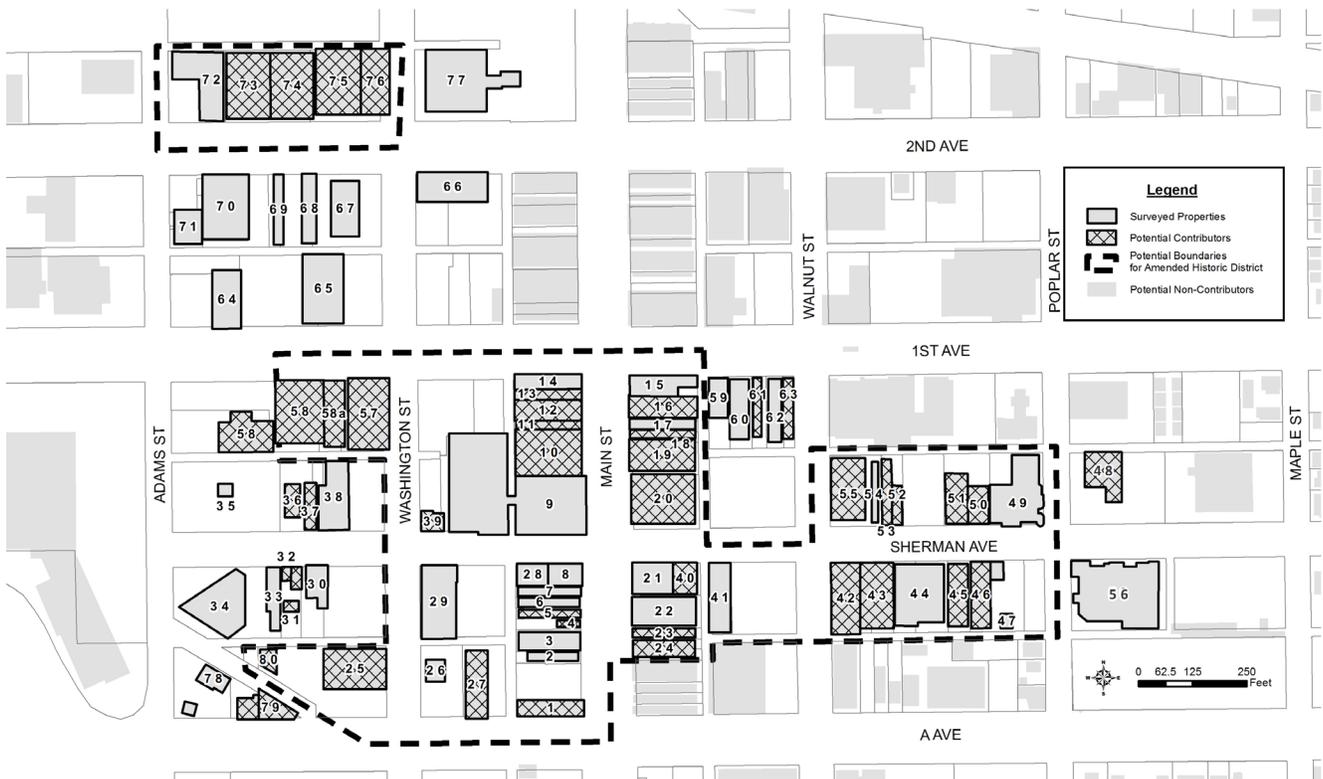
Figure 4: Proposed District Boundaries, Option B

Option B: Amend Existing Downtown Core North Historic District and Nominate Separate District for Motor Row

Option B would involve amending the Downtown Core North Historic District to include the properties identified on the map below. The amendment would append to the existing district nomination; it would not require edits

to the existing nomination text. The additional documentation would include architectural descriptions, histories and integrity statements for the added properties. Although this option would not cover all downtown properties under a single umbrella, it is the most cost-effective and simple approach. While the bulk of the properties would technically remain in two separate historic districts, they could be marketed as a single Downtown Historic District. Properties on Motor Row would be nominated as a separate district under a separate historical context.

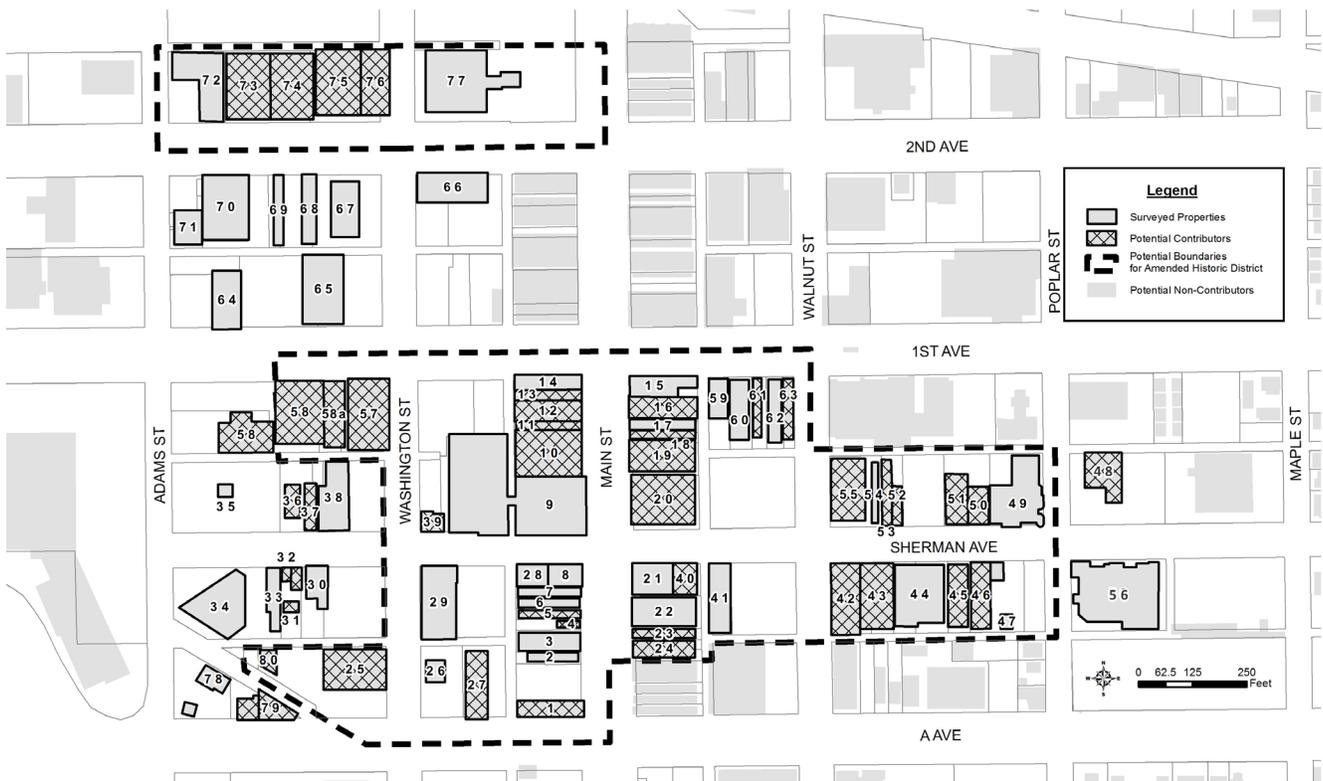
Figure 5: Proposed District Boundaries, Option C

Option C: Amend Existing Downtown Core North Historic District (Landmarks Commission Preferred Option)

Option C would involve amending the Downtown Core North Historic District to include the properties identified on the map below. This option would be similar to that offered above, but would include the additional properties located along Motor Row and East First Avenue – as well as any required additional context. Motor Row: The properties along the north side of Second between Adams and Washington were constructed in the 1920s for auto-related purposes after street improvements were made to better connect downtown with the New Santa Fe Trail, later known as Highway 50. With the exception of the westernmost building (#72),

all of these buildings retain a high degree of architectural integrity, with appearances that strongly interpret their 1920s auto-related history and contemporary development. While these properties could be incorporated into a separate historic district, the simplest approach would be to include these properties within an amended Downtown Core North Historic District. While this would require the inclusion of a non-contributing property, Data Center (#77), this row of significant buildings with a high degree of integrity should be included. East First: The amended district would also include survey sequence #59-63, 72-77, and the vacant lot south of properties #59-63. In its meeting on May 9, 2013, the Hutchinson Landmarks Commission passed a resolution in support of Option C.
